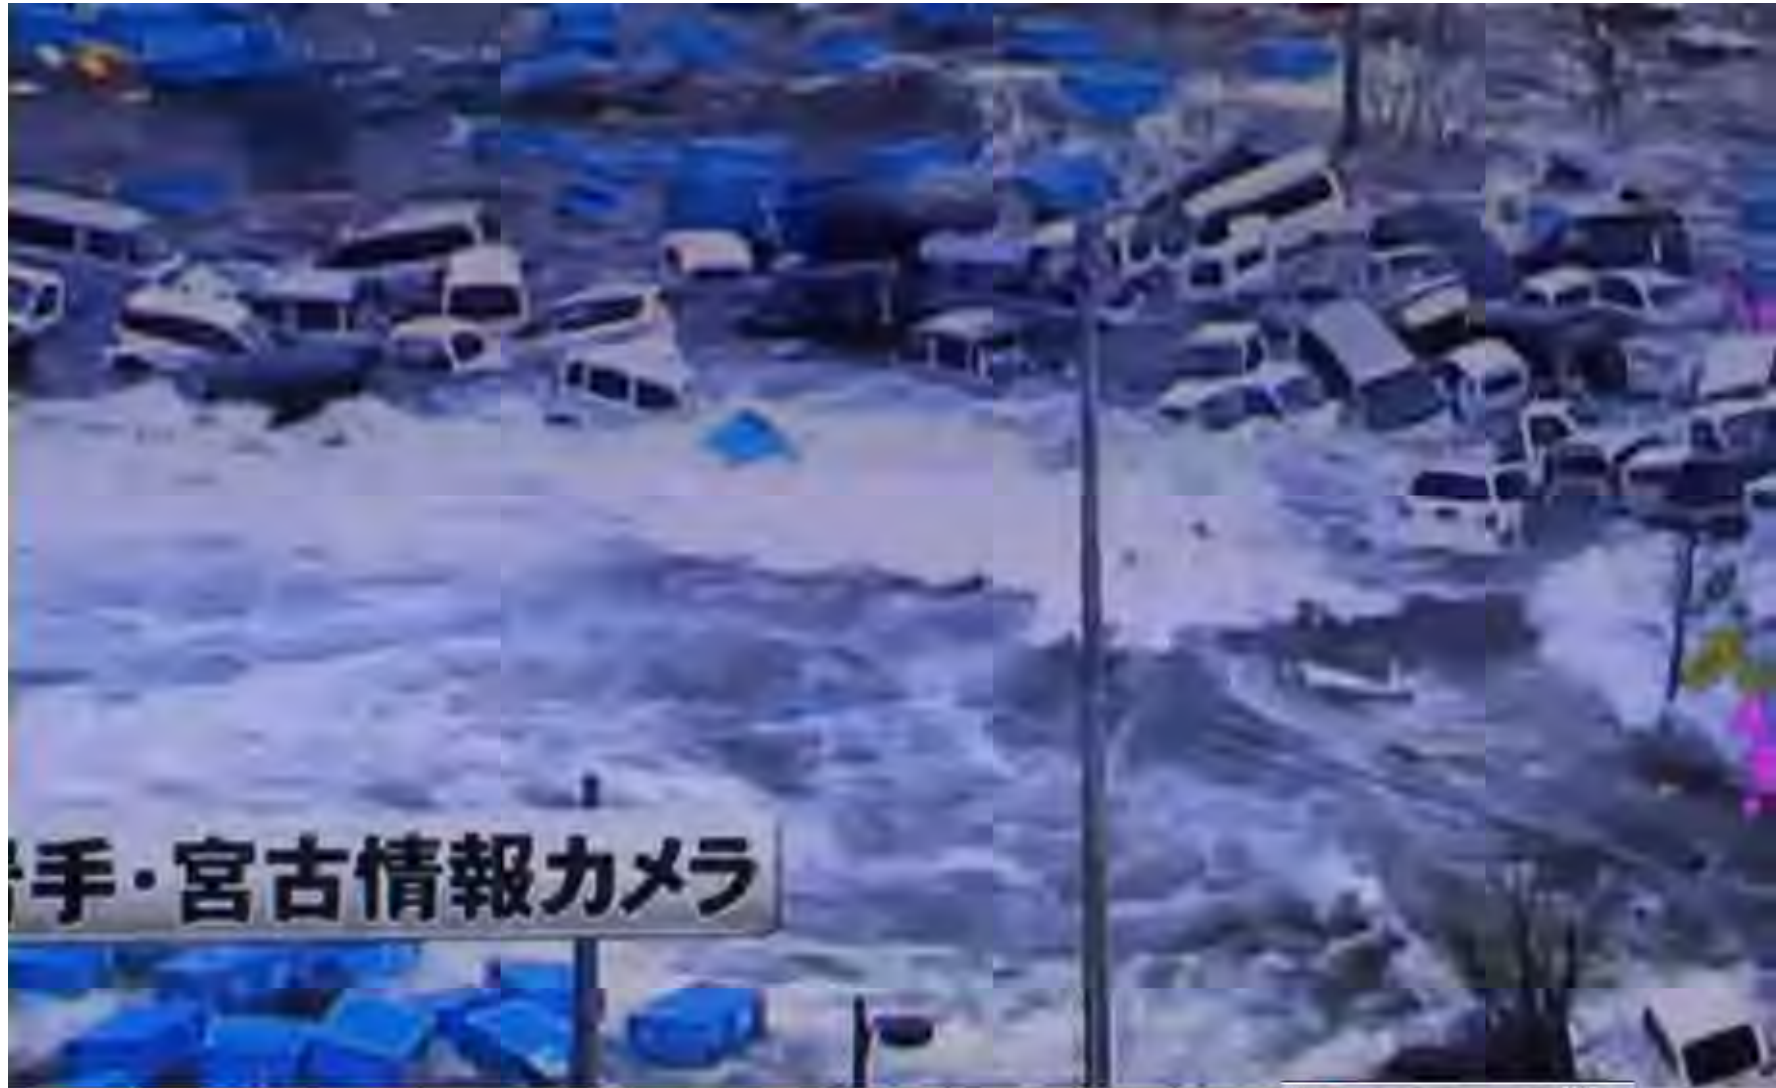
**Fig.2a Tsunami attacking Miyako City, Iwate Pref.
At 3pm, March 11, 2011 (The height: 10m)**

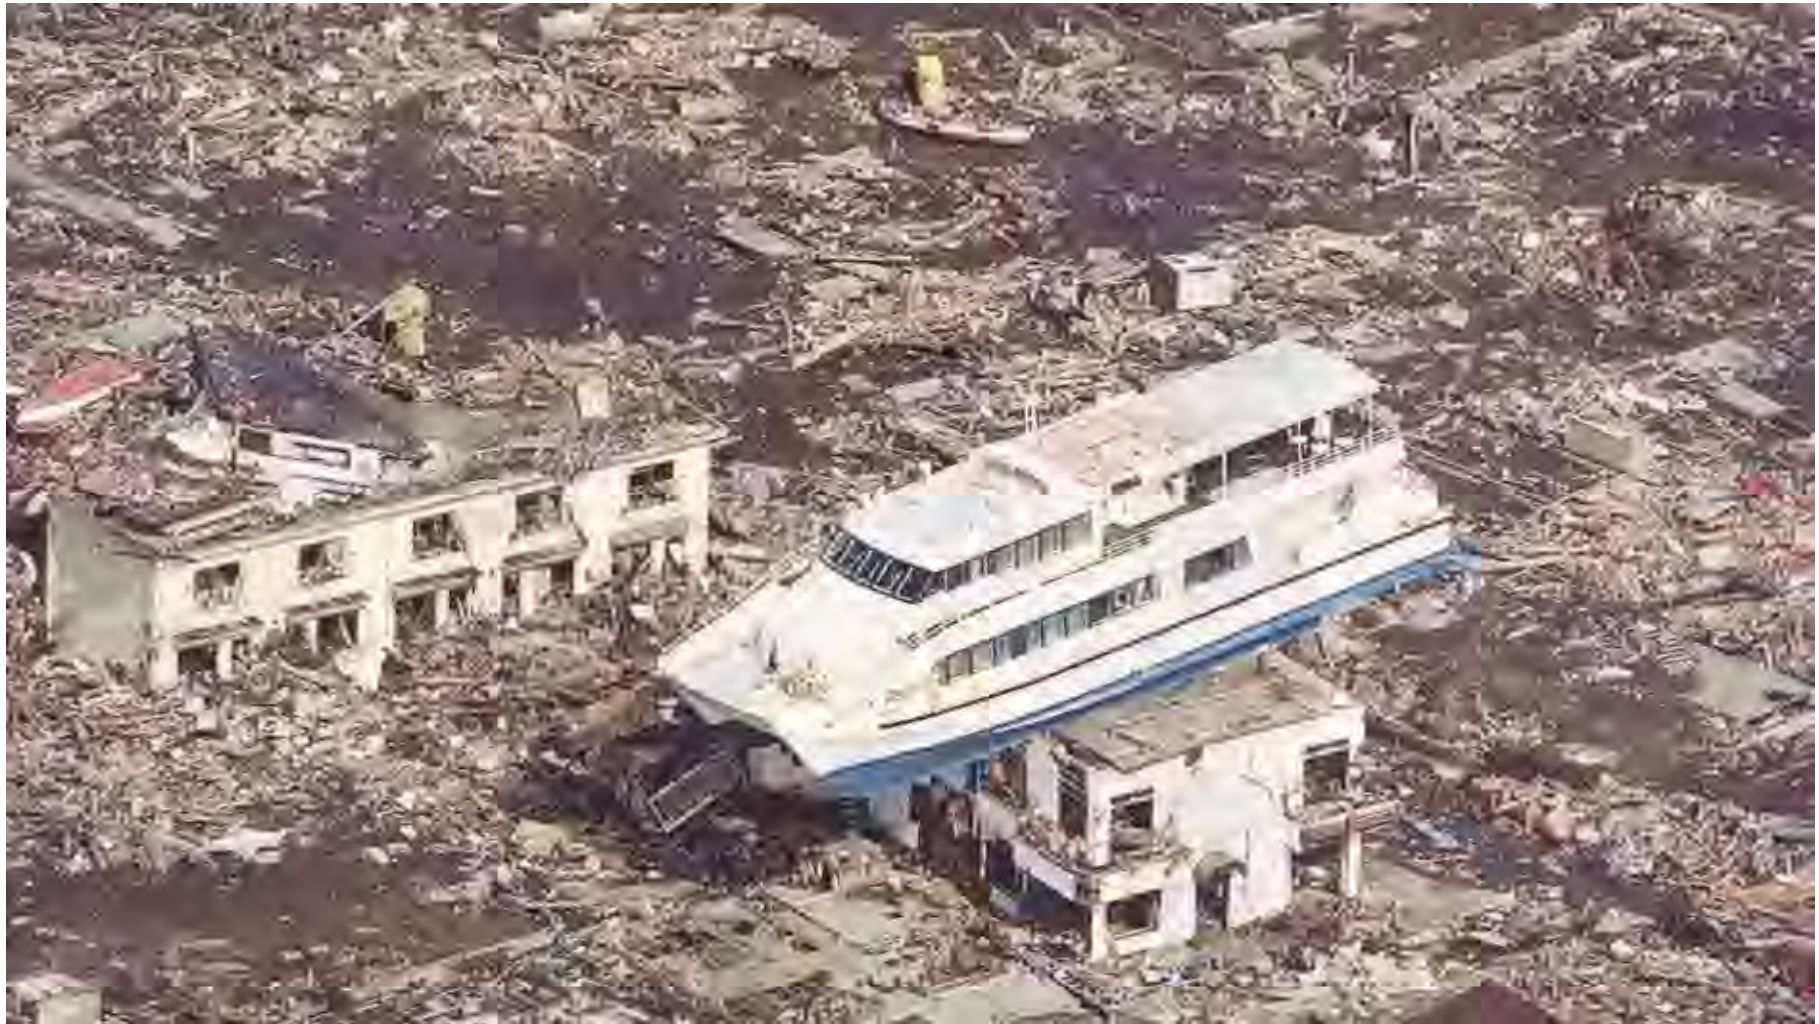
Fig.2b A big boat flown on the roof of a building in Otuchi Town, Iwate Prefecture

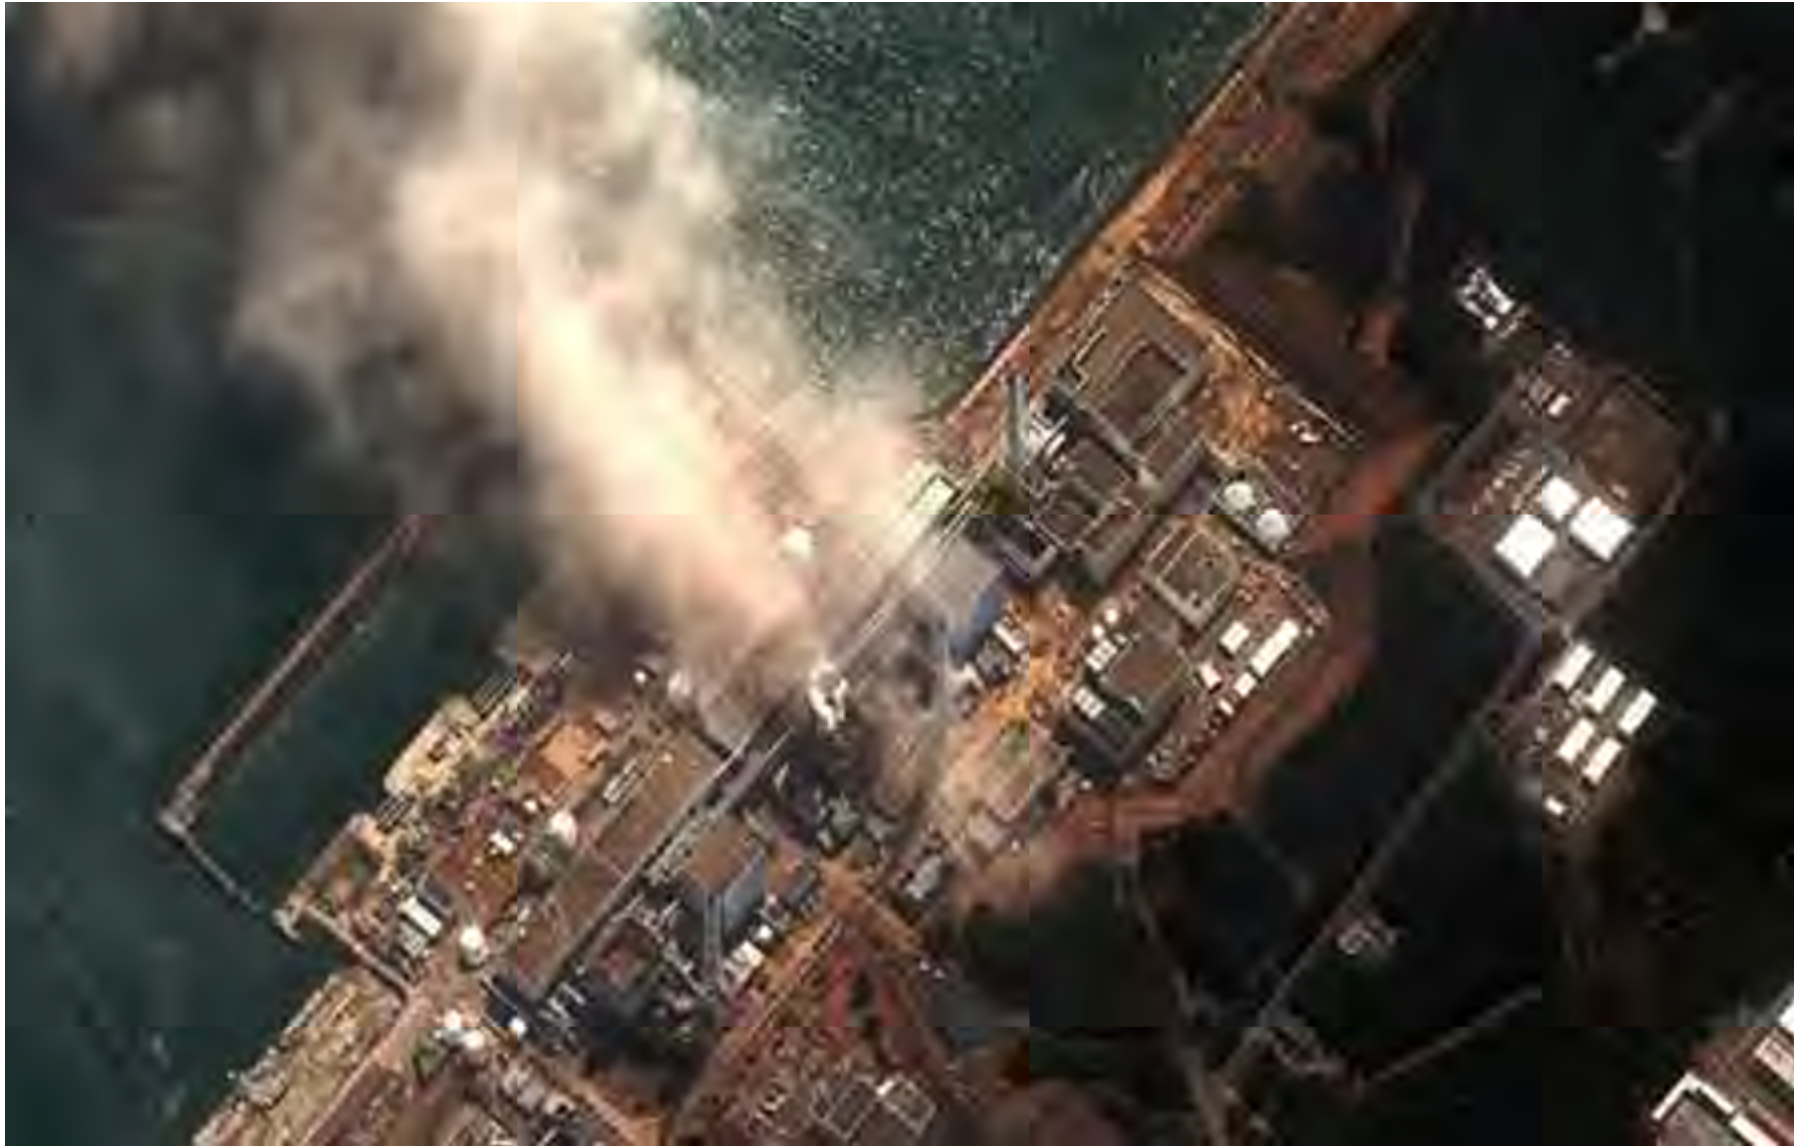
Fig.3 Accident of Fukushima Nuclear Power Plants with Hydrogen Gas Explosion

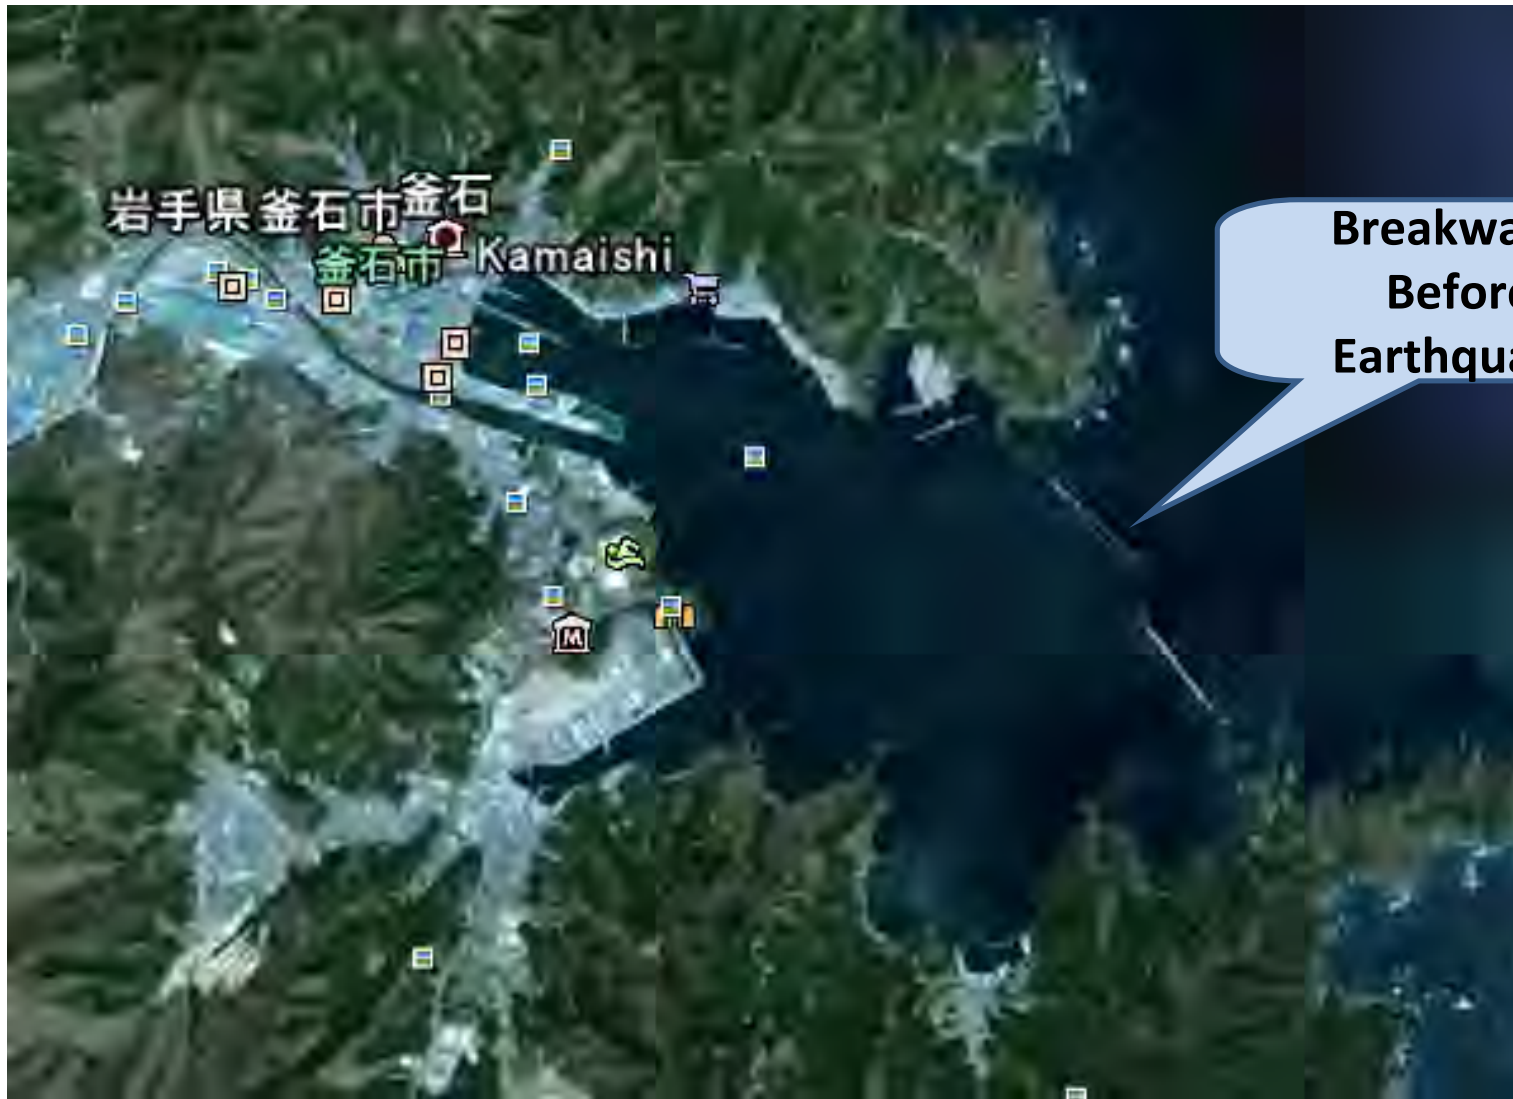
Fig.4a The Deepest Breakwater against Tsunami in Kamaishi Bay. Iwate Prefecture

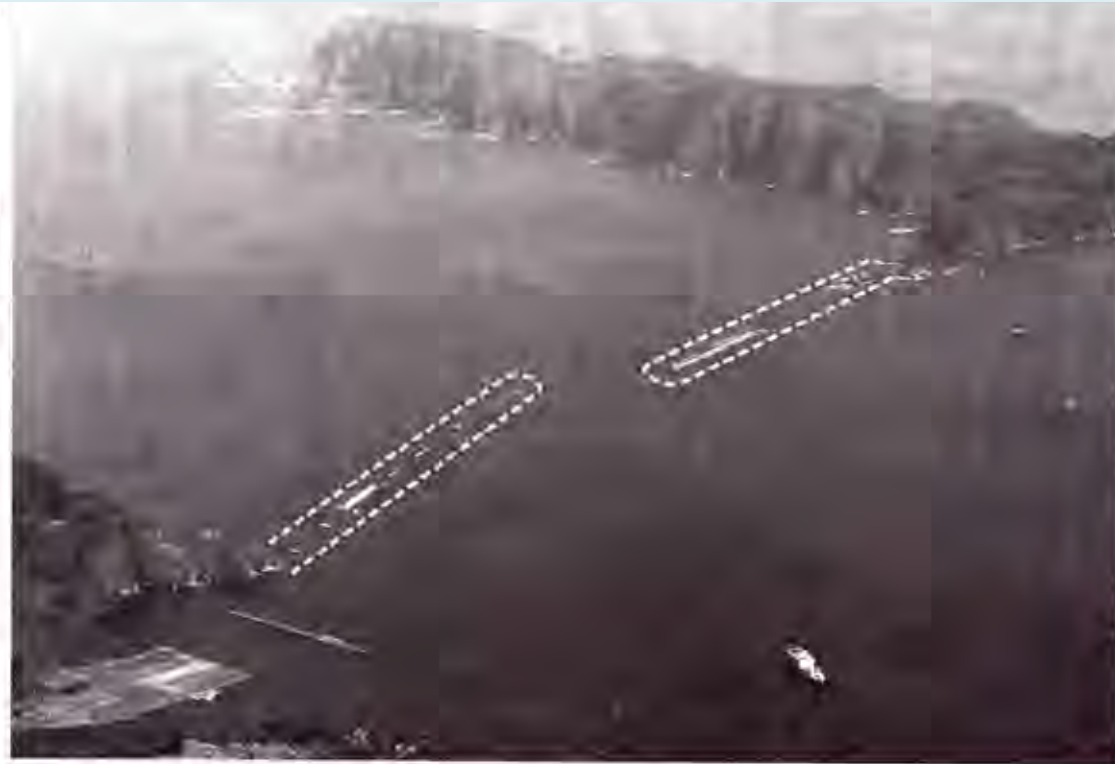
Fig.4b Destroyed Breakwater in Kamaishi Bay By Tsunami

世界最深の防波堤 無残

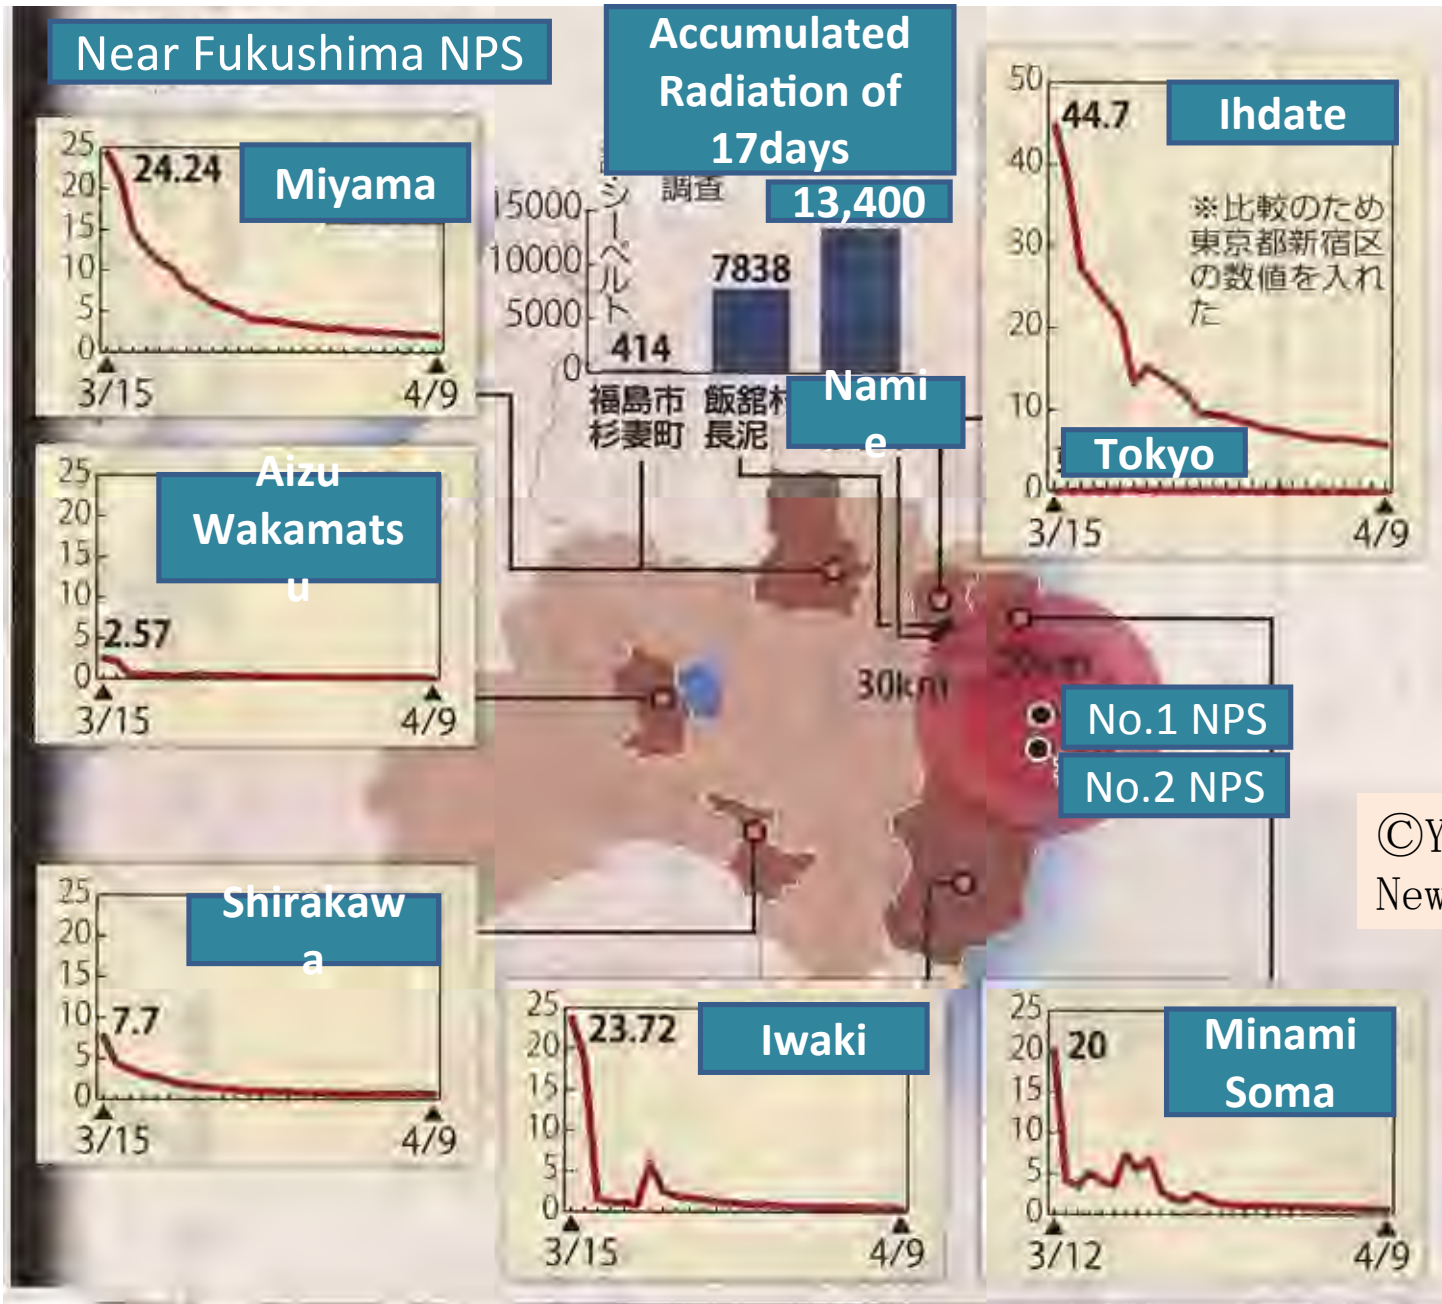
Fig.5 Trend of Atomic Radiation in Air: unit= μ sievert

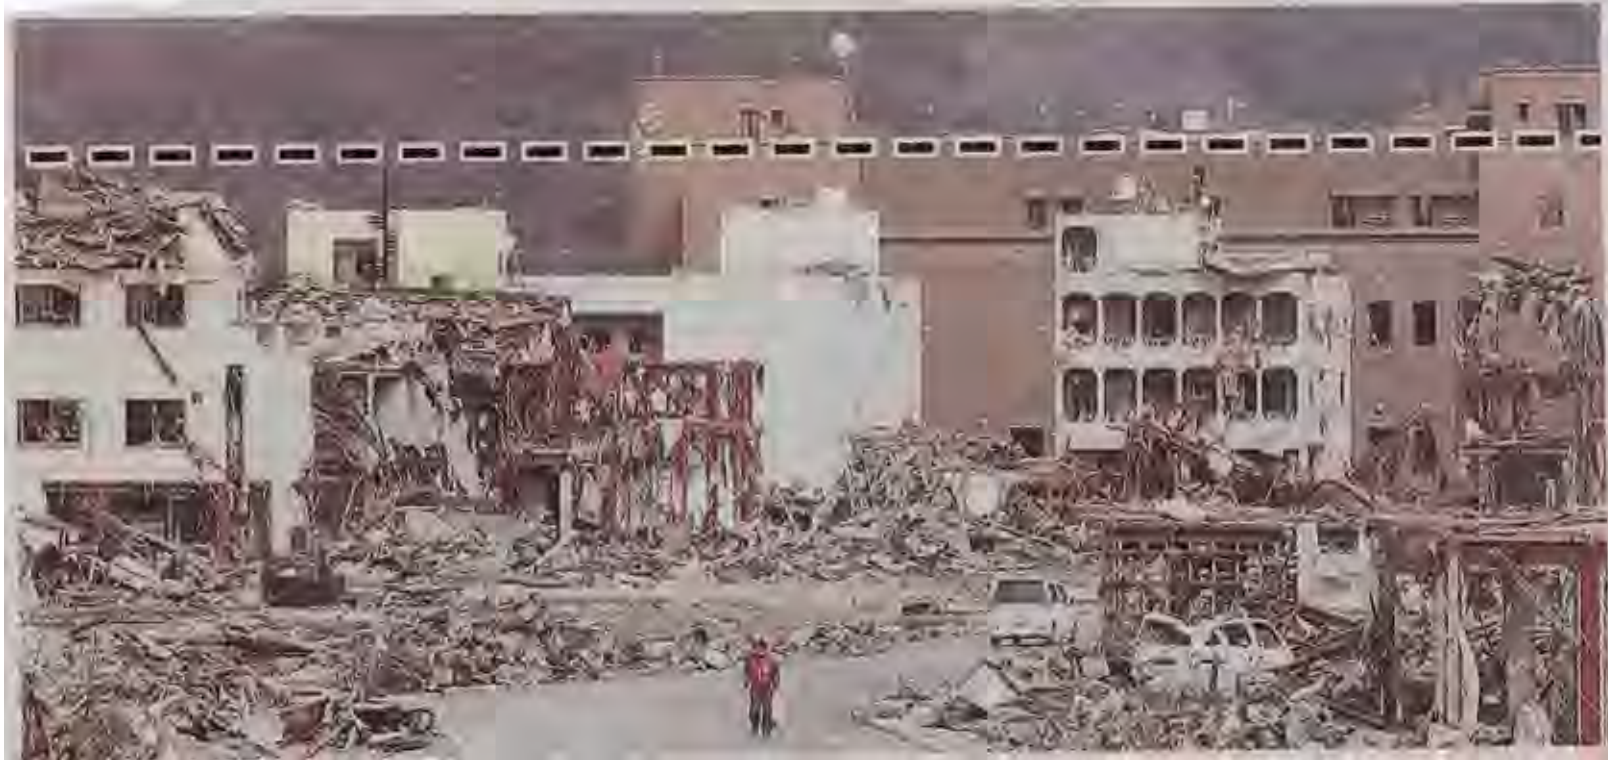
Fig.6 Water Level of Tsunami (15m) in Onagawa Town Up to the Roof of the Fifth Floor Building

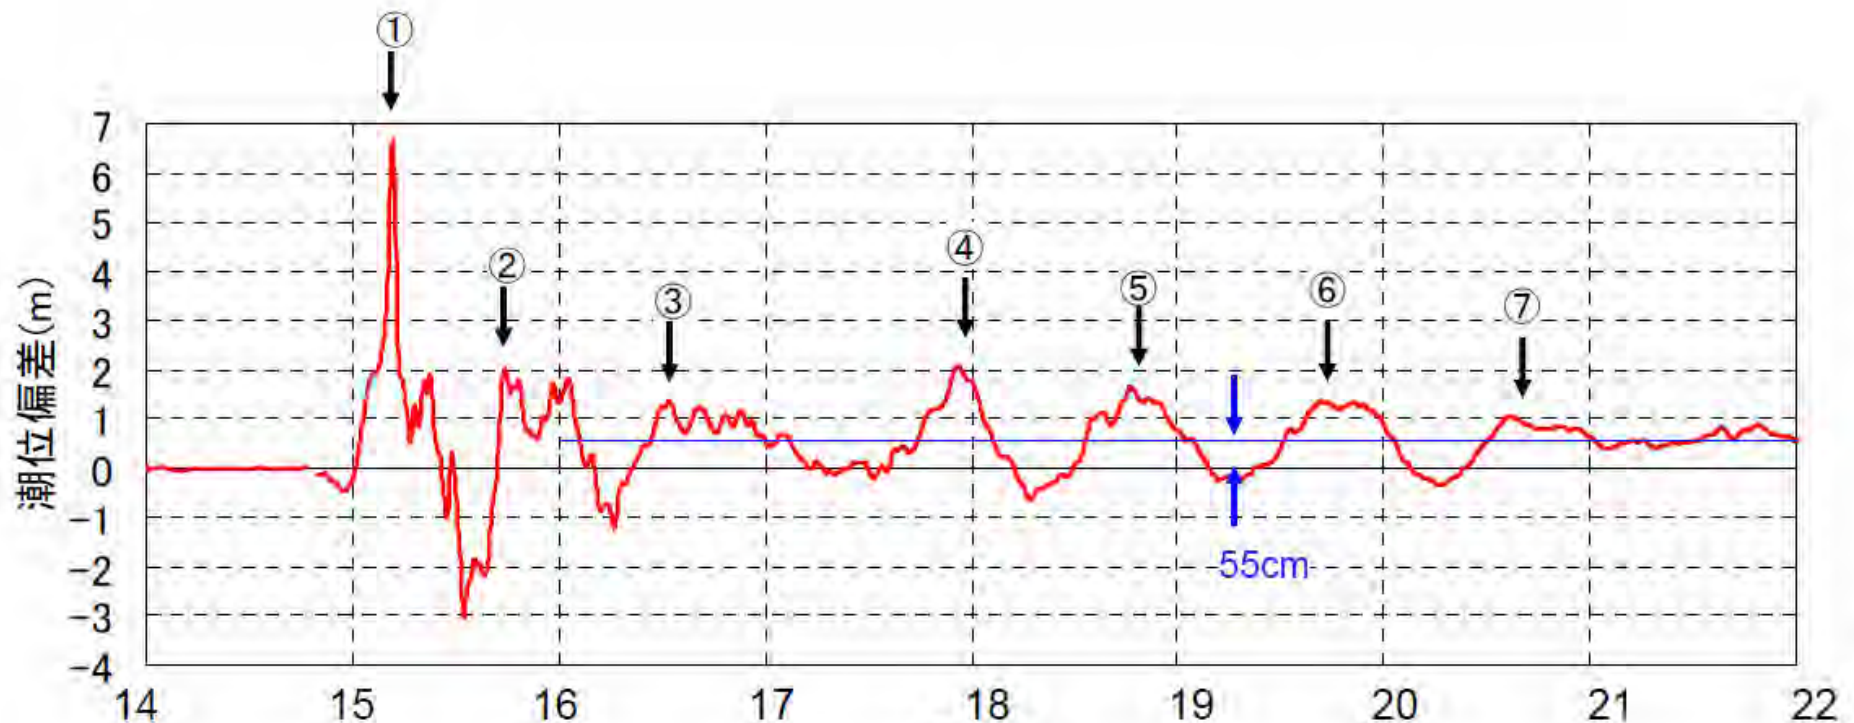
**Fig.8 GPS Tsunami wave height recorder at Kamaishi
(7 waves ranging 6.6 m to 1m attacked in 6 hrs.
The earthquake occurred at 14:46, 11 March 2011)**

Measured from 14:00 to 22:00, 11 March 2011
